UPDATE Technical Bulletin

91N9 UPDATE – MIB2 MQB Modular Infotainment System Software Update (NVLW)

Model(s)	Year	Engine Code	Trans. Code
Golf, GTI, Golf Sportwagen	2016	All	All

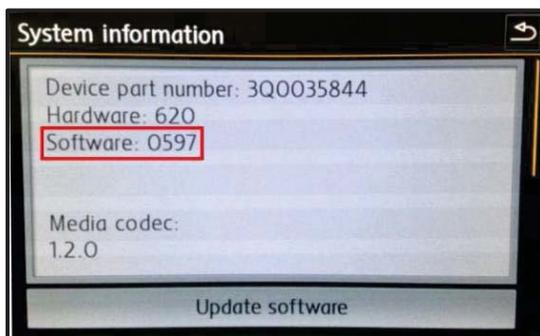
- If the currently installed software level is LOWER than **0613** <as shown>, proceed with these repair instructions.
- If the currently installed software level is GREATER than or EQUAL to **0613**, this work procedure does not apply.
